## RETROFITTING OF AUDITORIUM BUILDING

P. S. Patankar <sup>(1)</sup>, Suneel Voditel <sup>(1)</sup> and Devarsh Bhonde <sup>(2)</sup>

<sup>(1)</sup> M/s. Skyline Consulting Engineers Pvt. Ltd, Nagpur, India

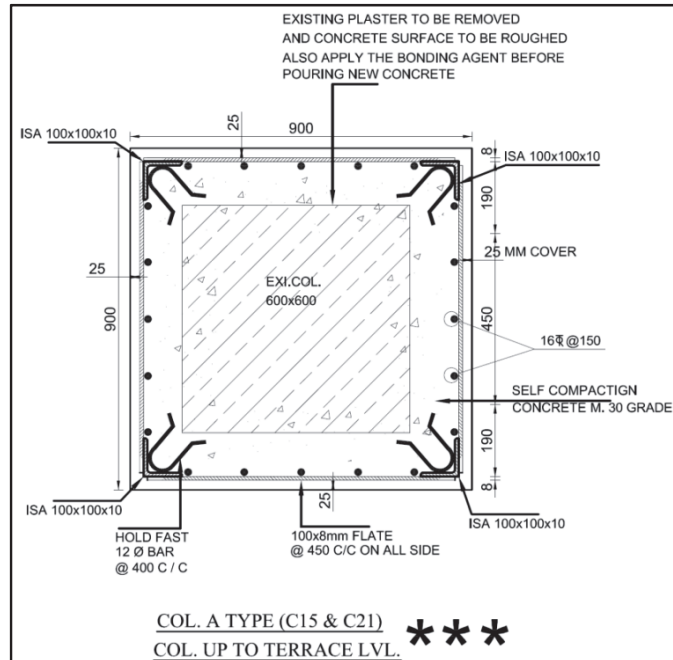
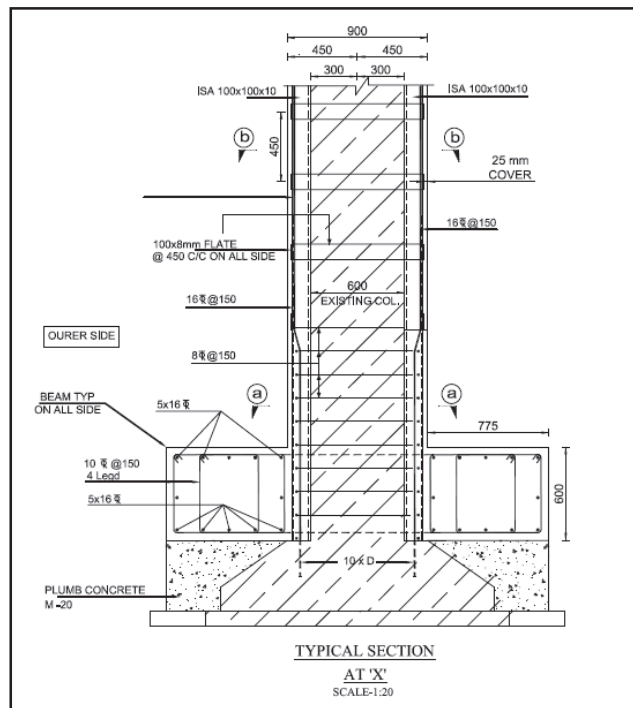
Figure 2: Strengthening of Columns

The RCC columns 600 × 600 mm in M-20 grade of concrete were provided in the structure those were subjected to axial load of 3500 kN and a bending moment of 708 kN-m. The section required to withstand the axial load and bending moment should be 600×600 mm with 8342 mm<sup>2</sup> steel. Whereas the existing column section was of RCC 600 × 600 mm, with 8-25 Tor and 12-16 Tor as main reinforcement, thus total amount of steel provided is 6330 mm<sup>2</sup> only, against the minimum requirement of steel of 8342 mm<sup>2</sup>. Thus, the columns were not safe to withstand the axial load and bending moment. It was also pointed out that the diameter of lateral ties (6 mm) was not in conformity with the provision of Indian Standard IS-456.

The existing columns were square in section of size 600 × 600 mm. It was proposed to strengthen these columns by increasing their size to 900 × 900 mm by additional RCC, as shown in Figure 2

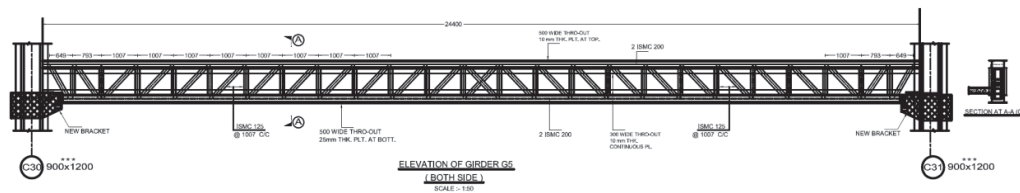
Figure 4: Elevation of Girder G-5

| Girder No. | Section | Zxx (mm <sup>3</sup> ) | MR (kN-m) (Bending Stress=150 N/mm <sup>2</sup> ) | Actual Bending Moment in kN-m | Zxx required (mm <sup>3</sup> ) | Remark | Capacity in % |
|---|---|---|---|---|---|---|---|
| G5 | 180x840 | 4900516.4 | 735.08 | 1972.85 | 13152333.33 | Fail | 37.26 |

- It was proposed to strengthen the girder G-5 by providing additional members and the strengthening of G-6 girder would be done by pre-stressing method.
- Before starting any fabrication work proposed for strengthening the girder G-5, the existing girder G-5 was propped by providing minimum 3 jacks each of capacity not less than 20 Tons at equal intervals.
- The strengthening of girder G-5 was carried out by providing additional members and the fabrication work was carried out at the site i.e. at position of G-5. The girder G-6 was supported by providing 3 jacks (same as proposed for girder G-5).

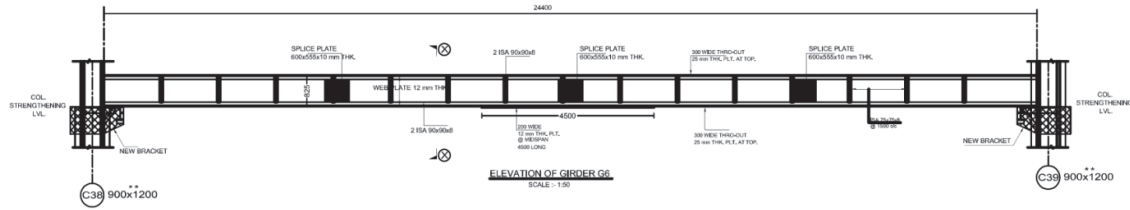
Figure 5: Elevation of girder G-6

| Girder No. | Section | Zxx (mm <sup>3</sup> ) | MR (kN-m) (Bending Stress=150 N/mm <sup>2</sup> ) | Actual Bending Moment in kN-m | Zxx required (mm <sup>3</sup> ) | Remark | Capacity in % |
|---|---|---|---|---|---|---|---|
| G6 | 300x1015 | 14842530.99 | 2226.38 | 3731.44 | 24876266.67 | Fail | 59.67 |

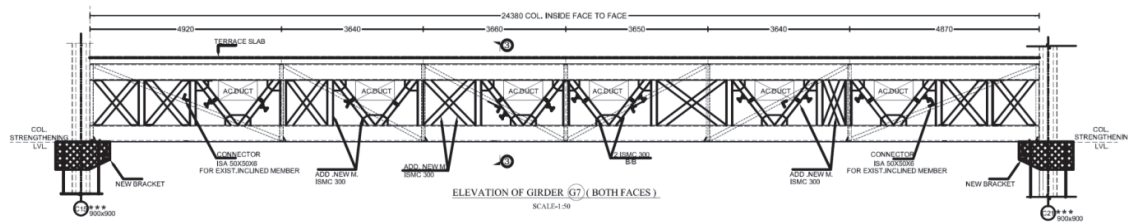
Figure 7: Elevation of girder G-7

| Girder No. | Section | Zxx (mm <sup>3</sup> ) | MR (kN-m) (Bending Stress=150 N/mm <sup>2</sup> ) | Actual Bending Moment in kN-m | Zxx required (mm <sup>3</sup> ) | Remark | Capacity in % |
|---|---|---|---|---|---|---|---|
| G7 | 232x2000 | 38481610.74 | 5772.24 | 8969.78 | 59798533.33 | Fail | 64.35 |

- It was proposed to strengthen girders G-7 & G-8 by providing additional members.
- Before starting any fabrication work proposed for strengthening these girder G-7 and G-8, the existing girders were propped by providing minimum three jacks each of capacity not less than 20 tons, at equal intervals.
- The strengthening of girder G-7 and G-8 was carried out by providing additional members as shown in the drawing. The fabrication work was carried out at the site i.e. at the positions of G-7 & G-8.
- Painting the structure by anticorrosive paint in three coats.

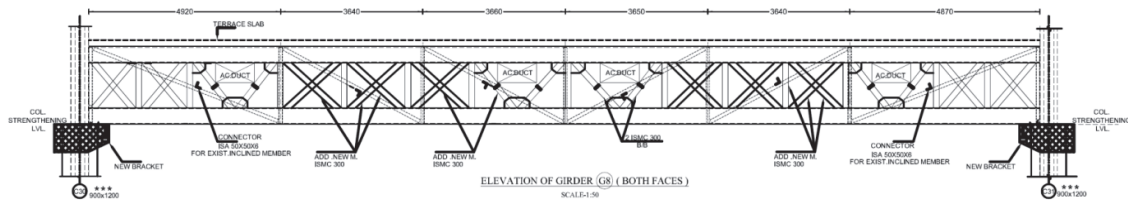
Figure 8: Elevation of girder G-8

| Girder No. | Section | Zxx (mm <sup>3</sup> ) | MR (kN-m) (Bending Stress=150 N/mm <sup>2</sup> ) | Actual Bending Moment in kN-m | Zxx required (mm <sup>3</sup> ) | Remark | Capacity in % |
|---|---|---|---|---|---|---|---|
| G8 | 232x2000 | 38481610.74 | 5772.24 | 7559.93 | 50399533.33 | Fail | 76.35 |
