## RETROFITTING OF AUDITORIUM BUILDING

P. S. Patankar <sup>(1)</sup>, Suneel Voditel <sup>(1)</sup> and Devarsh Bhonde <sup>(2)</sup>

<sup>(1)</sup> M/s. Skyline Consulting Engineers Pvt. Ltd, Nagpur, India

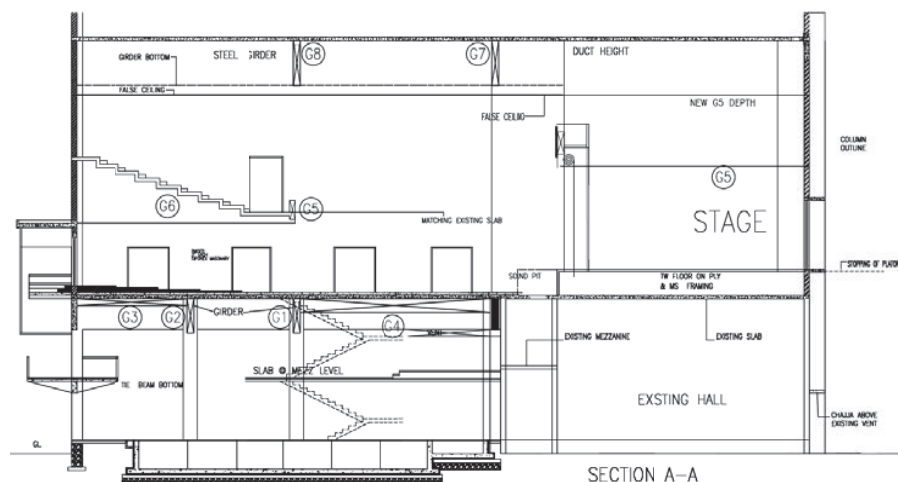
Figure 1: Existing architectural design with position of the girders

1. The girder above the swimming tank was sagged by around 80 mm.
2. Connections from bearing points of view were observed to be less.
